Seagrasses in the Leschenault Estuary

case study

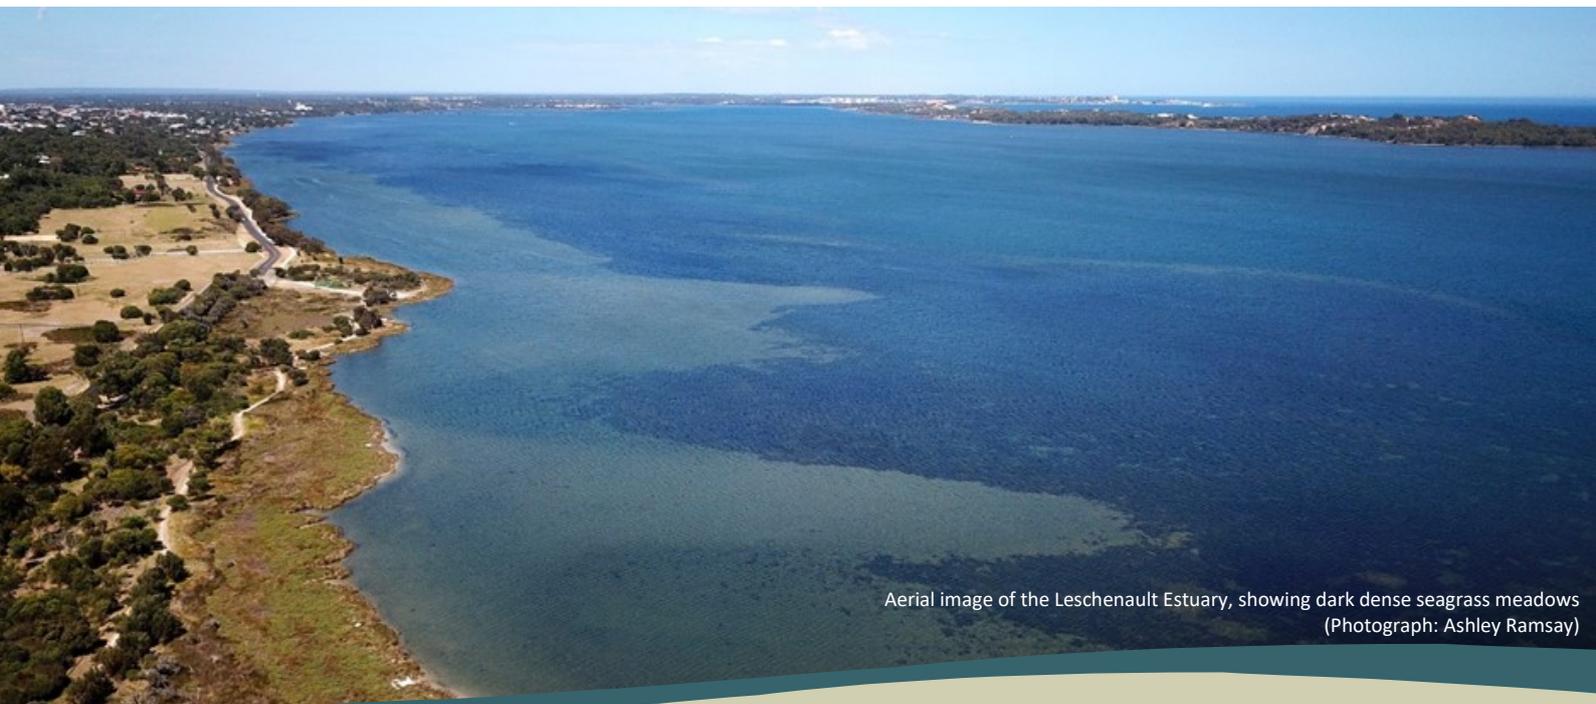
Aerial image of the Leschenault Estuary, showing dark dense seagrass meadows (Photograph: Ashley Ramsay)
